# Motorcycle Red Box Evaluation at Signalized Intersections in Bogor: Traffic Flow, Occupancy Rate and Stop Line Violation

<sup>1</sup>Institute of Road Engineering, Ministry of Public Works of Indonesia

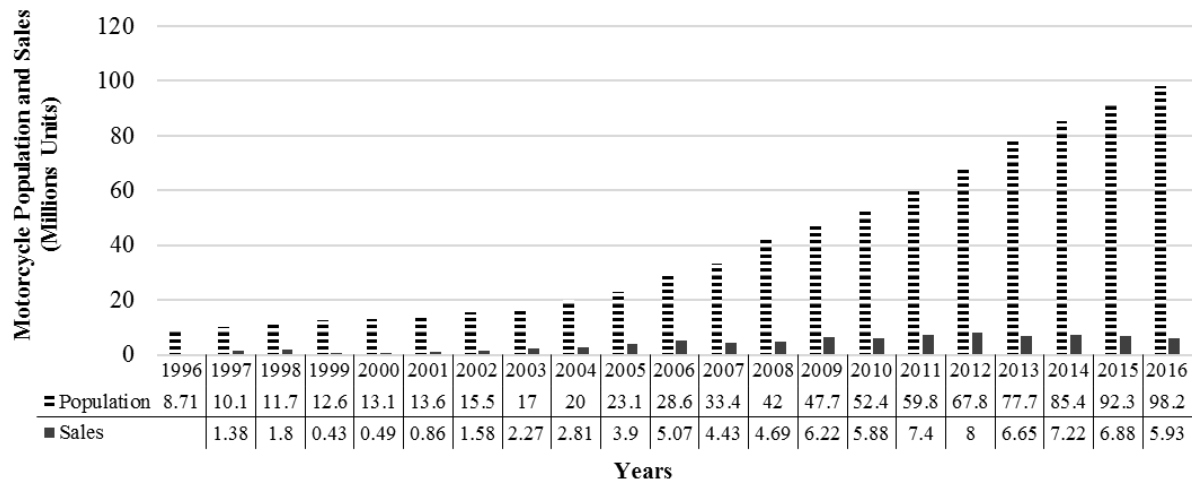
The main attracted factors of the motorcycle used because of some reason, such as affordable purchase price, cost of daily operations are cheaper, easy and inexpensive to maintain, capable to reach remote areas, does not require a large parking space and tend to free of congestion. The population and sales of motorcycles in Indonesia is shown in Figure. 1.

Figure. 1 Sales and Population of Motorcycle in Indonesia

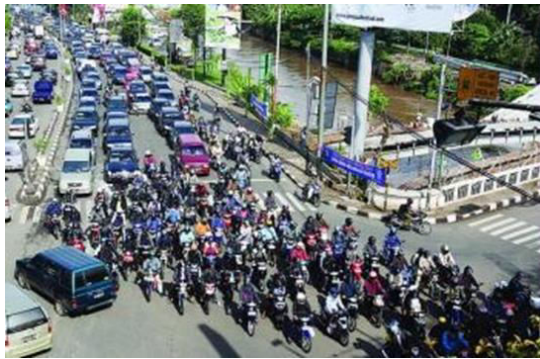
The accumulation of motorcycle disorder movement at intersection approach while waiting at the red light is a negative impact due to high motorcycle population as shown in Figure 2. The motorcycle disorder movement had caused stop line violation, blocked the left turn and obstructed the pedestrian movement. Thus, the large number of motorcycles had affected the performance of signalized intersections by decreasing the capacity.

Figure 2. The accumulation of motorcycle at intersection approach

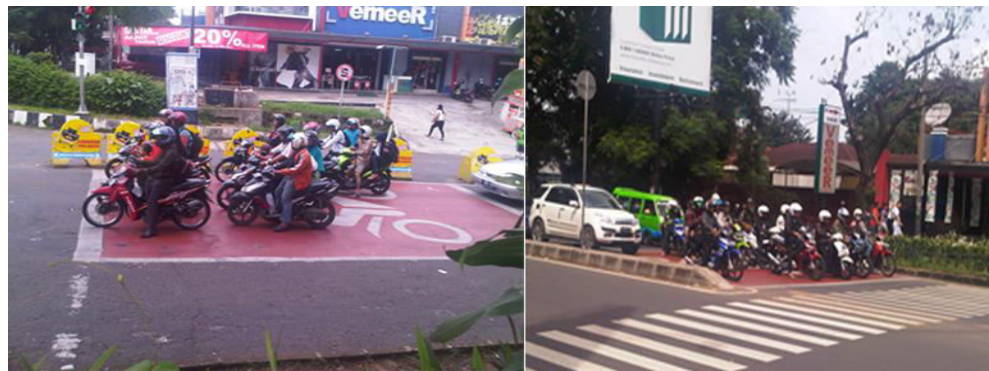
Figure 3. Implementation of Red Box for Motorcycle in Bogor

Implementation of Red Box for motorcycle at signalized intersections was developed from the concept of Advance Stop Lanes (ASL) for bicycles. ASL, also called advanced stop box or bike box, is road markings at signalized approach that allow certain types of vehicles to head start when the traffic signal changes from red to green. Advanced stop lines for bicycles were implemented widely in the United Kingdom, the Netherlands, Denmark, and other European countries. Therefore, this concept is tried to be implemented for motorcycles. The Red Box for motorcycle was developed to split the queue between motorcycles and other types of vehicles when waiting at red light. [1].

In general design, the first Red Box was designed by providing front stop line for motorcycle and back stop line for other types of vehicles. Both stop lines are separated by red area with solid marking. Red Box for motorcycle also continuous boundary road marking on the left and right side. There was motorcycle logo in the center of Red Box. That motorcycle logo was shown in the centre of red area to make motorcyclists easy to understand and aware what the meaning of Red Box is.

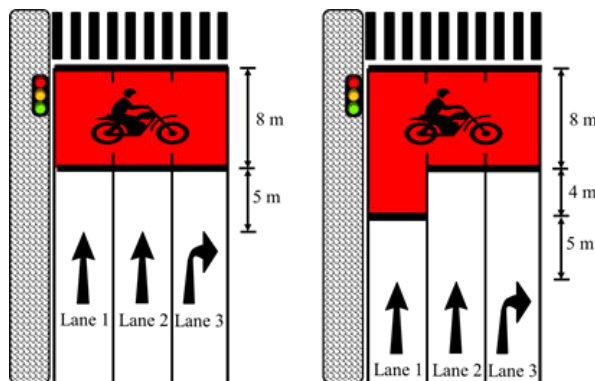
There are two types of Red Box for motorcycle, the box type and the P type. Box type is designed with box shape and it is applied if the proportion of motorcycle at each lane is relatively same. P type is designed with P shape which is added by extension area at the left lane. This extension area is designed to accommodate the large proportion of motorcycle that moves on the left

lane. P type is only applied when the proportion of motorcycle on the left lane is greater than 60% and 70% for two lanes and three lanes of Red Box for motorcycle. On the contrary, if less than that value then the box type is applied. At this intersection, all Red Box was designed with box type and length 8 m. Scooter matic and underbone have average length around 2 m. Thus, the design Red Box with length of 8 m is able to accommodate four rows of motorcycles

Figure 4. Design of Box Type and P Type

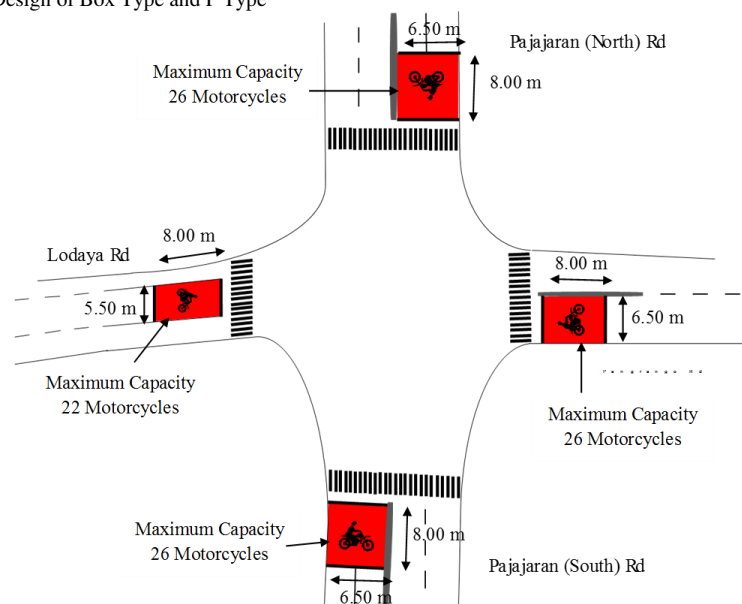
At the Pajajaran-Pangrango signalized intersection, all Red Boxes were design by 8 m length. Design of Red Box is shown in Figure 5

Figure 5. Design of Red Box at Pajajaran-Pangrango intersection

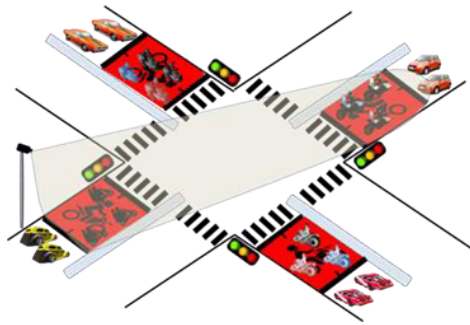
Data collections technique was done by using video camera device. Video camera was designed to record the traffic volume at the signalized intersection. Video camera was installed at high place that could cover the whole traffic movement which was observed at the intersection. Video camera was installed at the pole with a height approximately 6 meter above road surface. The distance from Red Box to the pole was around 20 meter behind the Red Box. By using video record, the traffic volume was counted in the laboratory. Figure 6 showed video camera placement at the signalized intersection.

Figure 6. The camera placement at the Red Box location

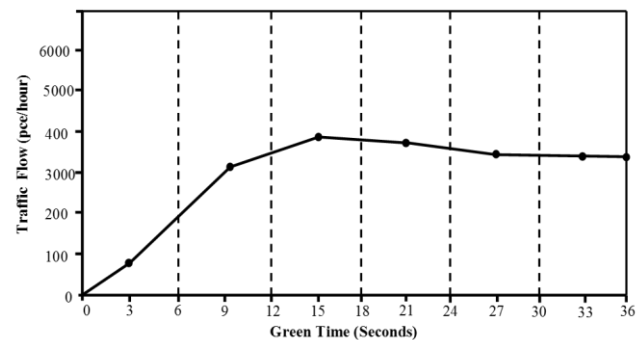
It can be seen from Figure 7 that the traffic flow started from 0 second at the green light and it reached a peak after 12-18 seconds. After that the traffic flow decreased slightly and remained stable until the end of green light. At the beginning of traffic flow, lost time occurred. Start-up lost time happened when the traffic signal changed from red to green. Some amount of time elapsed between the signal changing from red to green and the first queue vehicle moving through the intersection. There is additional amount of time for the next vehicle to begin moving and passing through the intersection. The total time taken for all waiting drivers to react and accelerate was the start-up lost time. Clearance lost time is the time lost to stopping a line of vehicles at the end of a green light. Traffic flow was analysed by comparing data before and after implementation of the Red Box. The typical traffic flow diagram is shown in Figure 7 (Indonesia Road Capacity Manual, 1997).

Figure 7. Typical traffic flow diagram

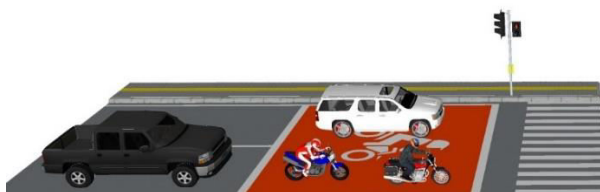
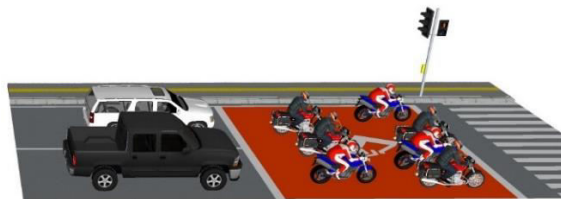
Wrong → Not only motorcycle occupied the red box

Correct → Only motorcycle occupied red box

Figure 8. Illustration of only motorcycle or not only motorcycle occupied Red Box

The presence of non-motorcycles at the Red Box area while waiting at the red light indicated marginal implementation of the Red Box. This is due to lack of discipline, lack of enforcement and inadequate design of the Red Box area. To calculate occupancy rate by

motorcycles only is shown in equation 2. In addition, the assessment of occupancy rate by motorcycle only (IRE, 2012) is shown in Table 3 while Illustration of only motorcycle or not only motorcycle occupied Red Box is shown in Figure 8.

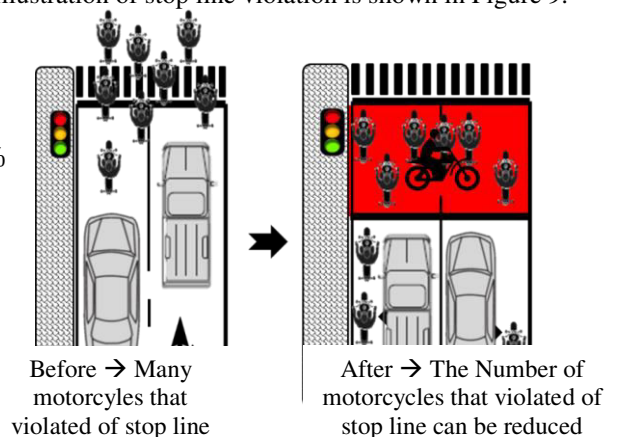
Red Box was intended to make the signalized intersection more organized, safe, and smooth. The stop line violation occurred when the motorcycles were waiting at the red light and motorcycles stop in front of stop line. The stop line violation rate before and after implementation became an indicator of the Red Box success. If the stop line violation rate after the implementation of the Red Box does not decrease or remains stable, it is necessary to review the design of the Red Box or motorcyclist behaviors. The data were collected by surveyor by counting directly the number of

motorcycles that violate at stop line on the site. The illustration of stop line violation is shown in Figure 9.

Figure 9. Illustration of Stop Line Violation (Before and After)

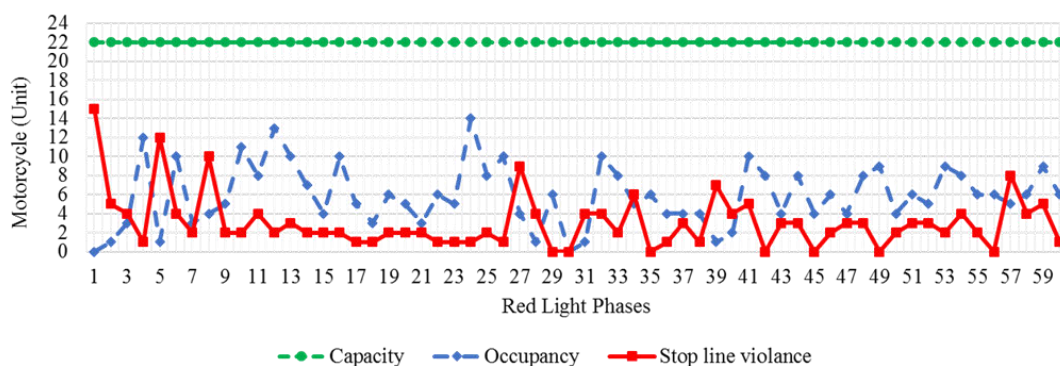
Red Box in Bogor has four intersection approaches. Firstly, Lodaya road that has an area of Red Box around 44 m<sup>2</sup> and it has the capacity of 22 motorcycles. According to the data survey as shown in Figure 10, the average number of motorcycles which waited during the red light was approximately 5 motorcycles per phase. It means the Red Box has only occupied approximately 22.70% of capacity. There were 60 phases of red light that were surveyed per one intersection approach. The number of motorcycles that broke stop line after red box implementation was approximately 3.07 (decrease 16.19%).

Figure 10. Occupancy and stop line violation at lodaya intersection approach

No	Data Analysis Parameter	Result (%)	Assessment	Remarks	
1	Occupancy rate to capacity	22.70	Poor		
2	Occupancy rate by motorcycle only	33.33	Poor		
3	Stop line violation	-16.19	Marginal	Before 3.66	After 3.07

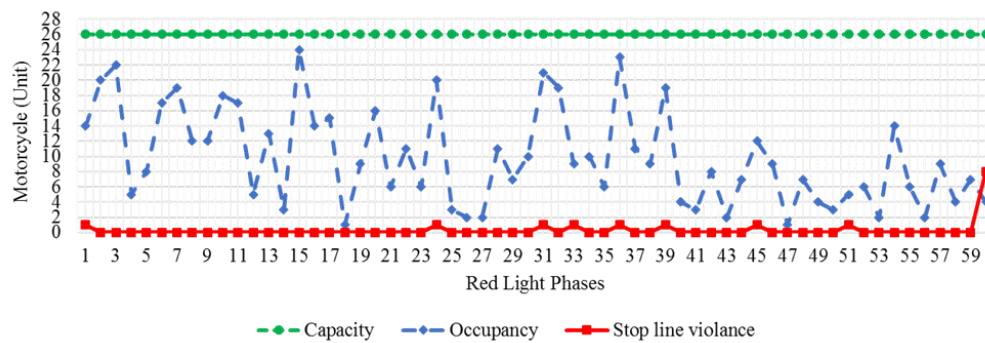
Secondly, the Pajajaran (south) intersection approach that has a size around 52 m<sup>2</sup> and the capacity of around 26 motorcycles. At this intersection approach, the

average number of Red Box occupancy was as many as 9 units of motorcycles per red light. Thus, it was only 34.60% of the capacity. The number of motorcycles that

broke the stop line line after red box implementation is 0.27 (decrease 79.14%). The occupancy and stop line

violation at Pajajaran (south) intersection approach is shown in Figure 11.

Figure 11. Occupancy and Stop Line Violation at Pangrango Intersection Approach

Assessment result at pajajaran (south) intersection approach					
No	Data Analysis Parameter	Result (%)	Assessment	Remarks	
1	Occupancy rate to capacity	34.60	Poor		
2	Occupancy rate by motorcycle only	68.33	Marginal		
3	Stop line violation	-79.14	very good	Before 1.29	After 0.27

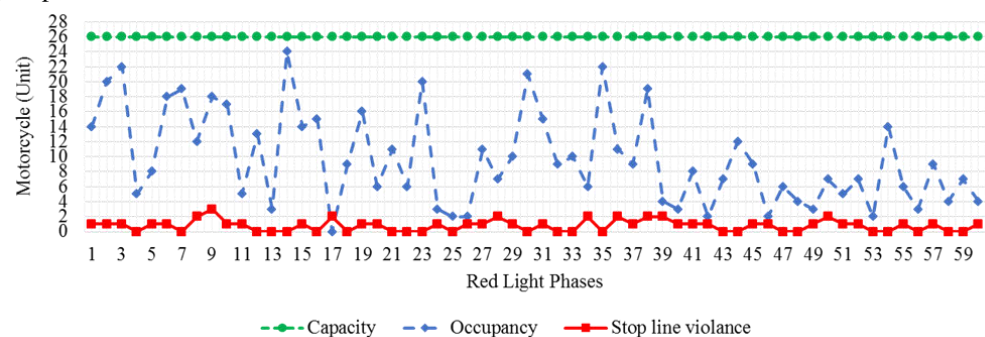
Thirdly, Pangrango road that has the Red Box area around 52 m<sup>2</sup> and the capacity reached 26 motorcycles. The average occupancy of the Red Box was only 10 motorcycle units or approximately 38.40% of capacity per red light phase. Furthermore, the number of

motorcycles that broke the stop line after red box implementation is 0.77 (decrease 89.88%). The occupancy and stop line violation can be seen in Figure. 12.

Figure 12. Occupancy and Stop Line Violation at Pajajaran Intersection Approach

Assessment result at pangrango intersection approach					
No	Data Analysis Parameter	Result (%)	Assessment	Remarks	
1	Occupancy rate to capacity	38.40	Poor		
2	Occupancy rate by motorcycle only	43.33	Poor		
3	Stop line violation	-89.88	very good	Before 7.60	After 0.77

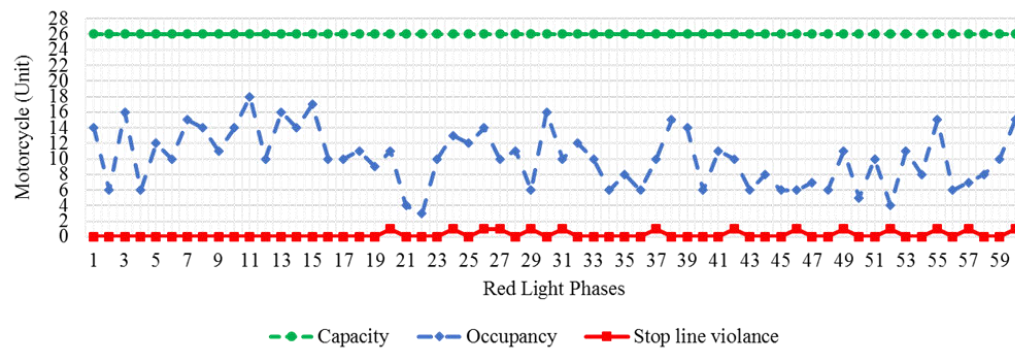
Fourthly, Pajajaran road (north) that has a size area of the Red Box around 52 m<sup>2</sup> and the capacity reached 26 motorcycles per red light. The occupancy of the Red Box by motorcycle at this intersection approach had an average of 10 motorcycle units or approximately 38.40%

of the capacity. In addition, the number of motorcycles that broke the stop line after red box implementation is 0.23 (decrease 72.56%). The occupancy and stop line violation can be seen in Figure 13.

Figure 13. Occupancy and stop line violation at pajajaran (north) intersection approach

No	Data Analysis Parameter	Result (%)	Assessment	Remarks
1	Occupancy rate to capacity	38.40	Poor	
2	Occupancy rate by motorcycle only	65.00	Marginal	
3	Stop line violation	-72.56	Good	Before 0.84 After 0.23
